DRAFT - Credenhill Flood Report – 15th/16th February 2020

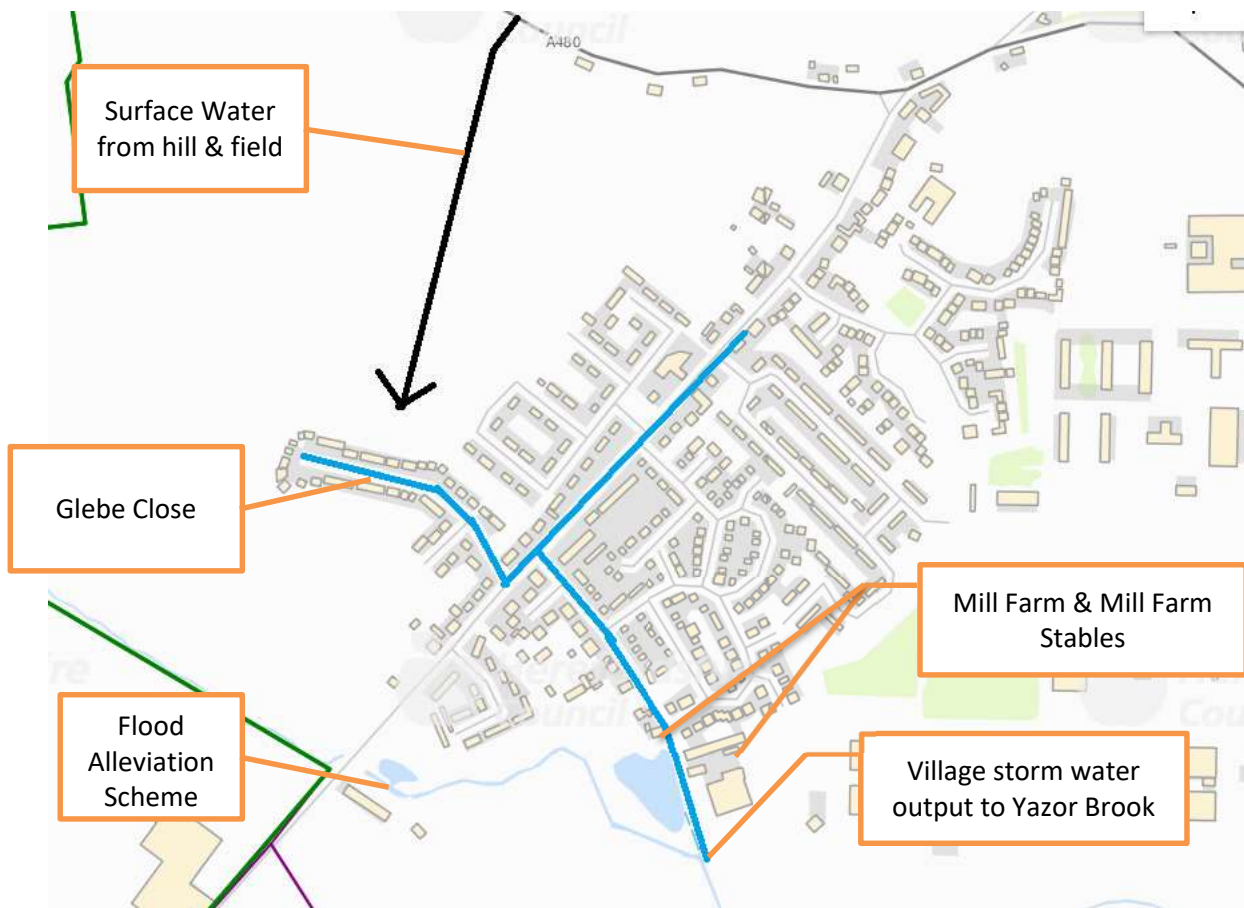
At the same time water from the hill had ran onto the A480 and was entering the farmers gate at the north of the field to the rear of glebe close.

The water followed the lie of the land, helped by several compacted tractor tracks down to the properties directly downhill of the gate. The field was unable to take the additional water due to the unprecedented amount of rain during the winter and therefore congregated at the rear of the properties to the north side of glebe close (numbers 57 – 70). Property owners became aware of the build up at around 3am. Numbers 60 and 61 opened their rear and front garage doors to prevent the water from getting into their homes. This allowed the water to drain from the rear of the properties through onto the road. However, due to the issues with the drains the water was unable to drain effectively from the road. The homes to the south side of Glebe Close, being lower than the road

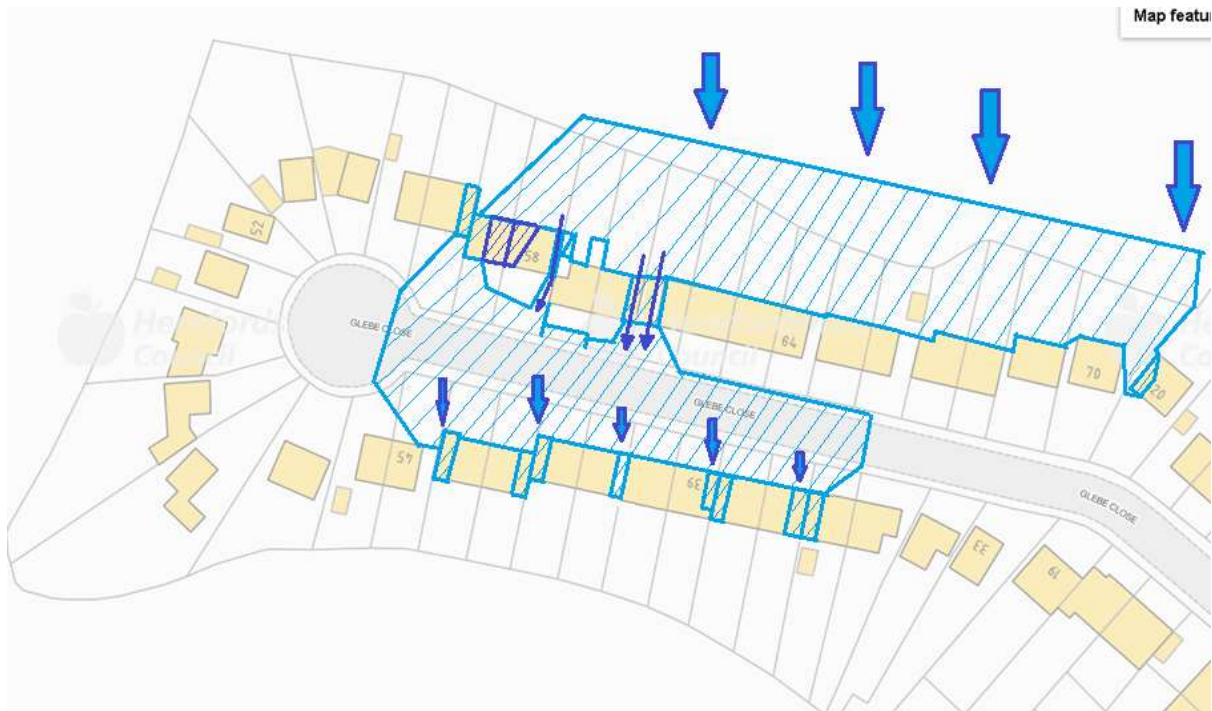
The below diagram shows the homes affected; this was created by speaking to homeowners in Glebe Close (See appendix 1):

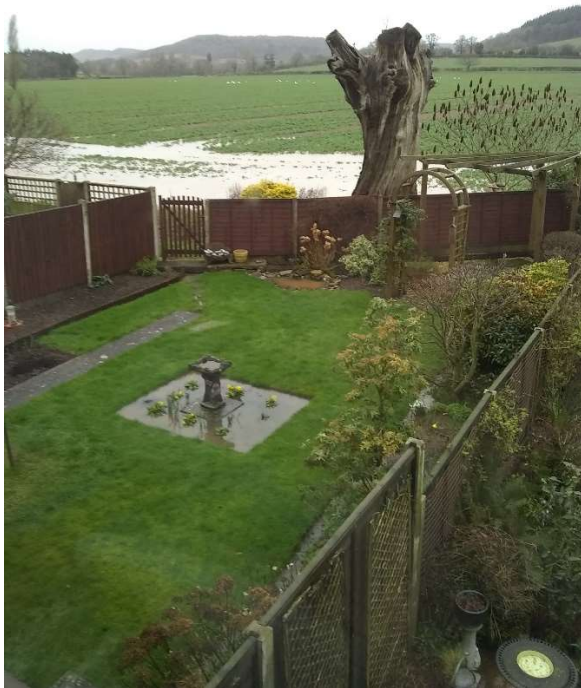
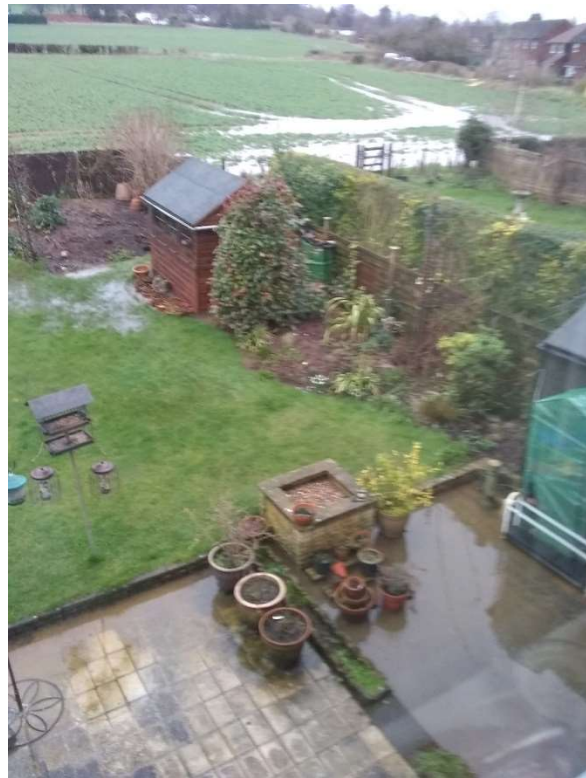
The below images show the field the next morning after the incident:

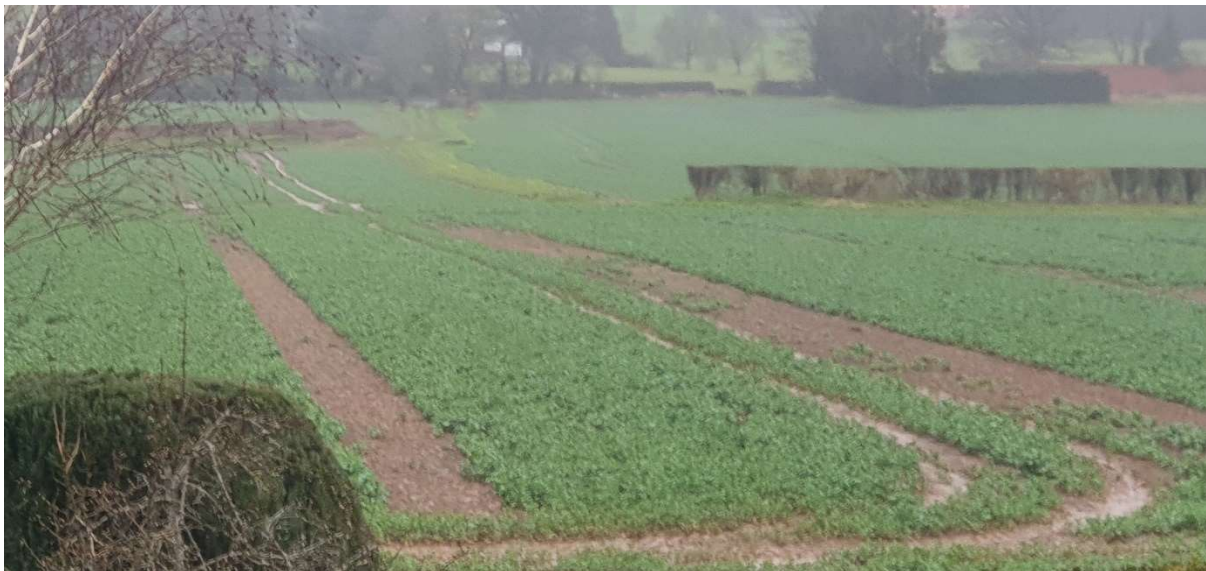
The below image shows the compacted tracks in the field (image taken after the water had drained):

Another solution would be to create a ditch and ridge to the rear of the Glebe Close properties. The farmer could also farm the land in a direction leading away from the properties so that the tram lines follow the slope towards the Yazor Brook instead of the slope towards the homes.

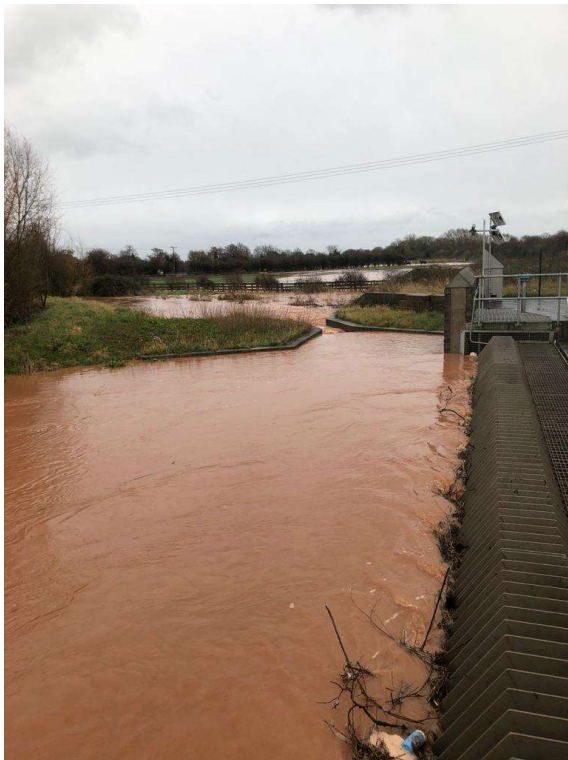
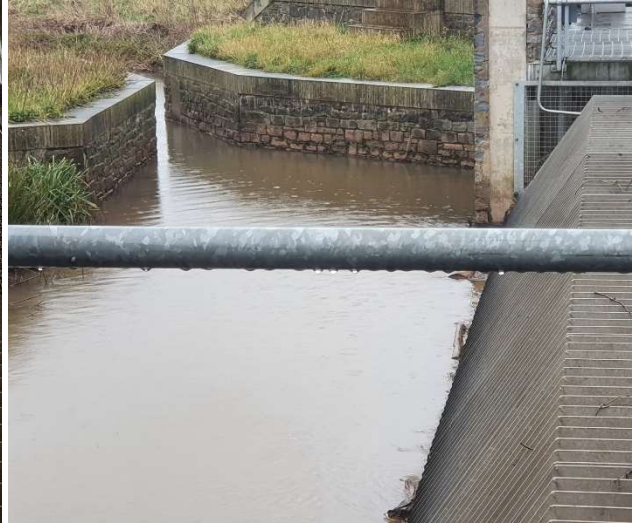
Flood Alleviation Scheme at 11am on 16th February compared to normal winter level

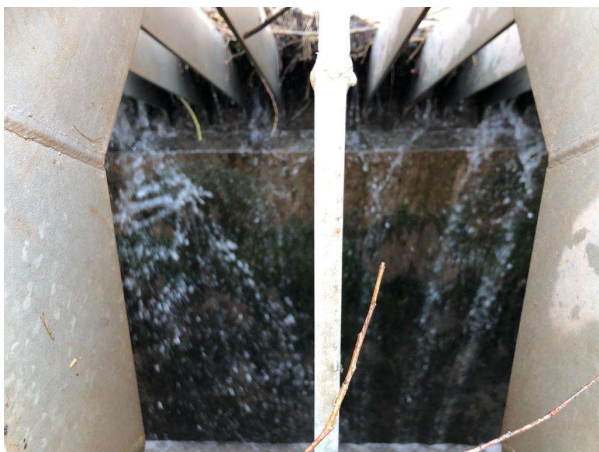
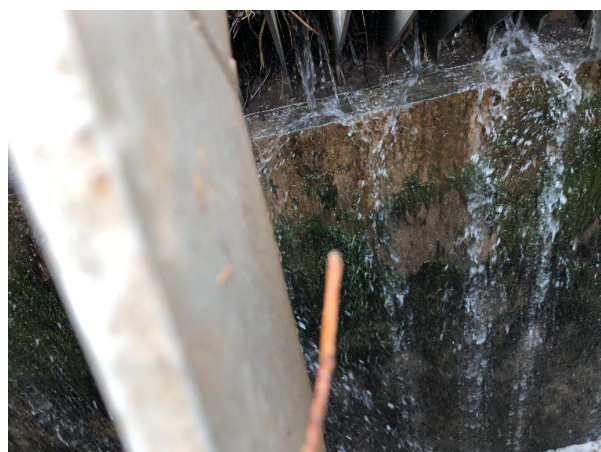
Blocked Grill:

While compiling this report it was established that a resident had cleared the grill on the flood alleviation scheme at 11.15am on 16th February 2020, the below images show the effect of clearing the grill.

Images show the difference in flow between a cleared grill and a blocked grill

It is clear from the images of the scheme being cleared that keeping the grill clear is an essential part of running an efficient scheme. If the grill had been kept clear then arguably the brook would never have reached the levels that caused flooding at the levels that were seen throughout the city (Roman Road, Three Elms, Ledbury Road - Texaco Garage). The backing up of the drainage pipe on Mill Lane, caused by the abnormally high level of Yazor Brook, which in turn caused Mill Farm & Mill Farm Stables to flood; would this of happened if the grill had been kept clear?

The culverts contain remote level sensors and the scheme has cameras to monitor the grill, could these be used to trigger an emergency response to ensure that Balfour Beatty are called out to clear the grill regardless of time/day? A 2-person team clearing the grill to ensure that the water is shepherded down the pipe would be better than having to deal with problems reactively after the event.

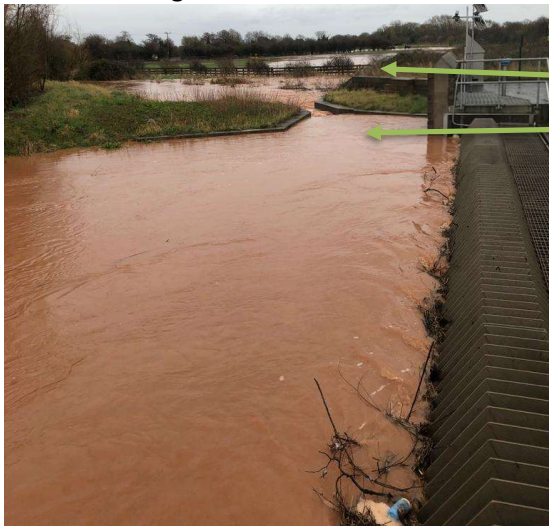
Before clearing

Flood Alleviation Scheme on 16th February 2020 at 12:00pm (after a resident had cleared the grill)
compared to before.

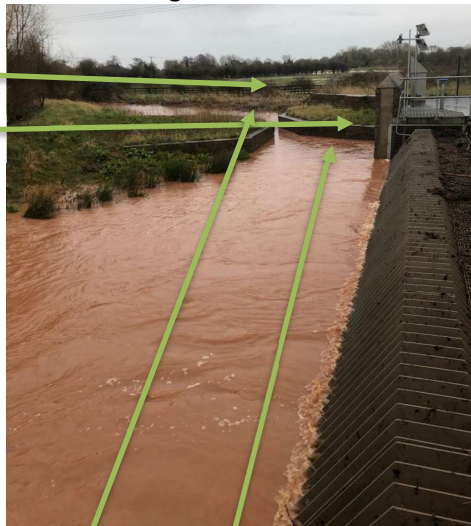
After clearing

Clearing of the grill reduced the level significantly in less than an hour; it also allowed the field to drain and prevented the brook from flowing into the field.

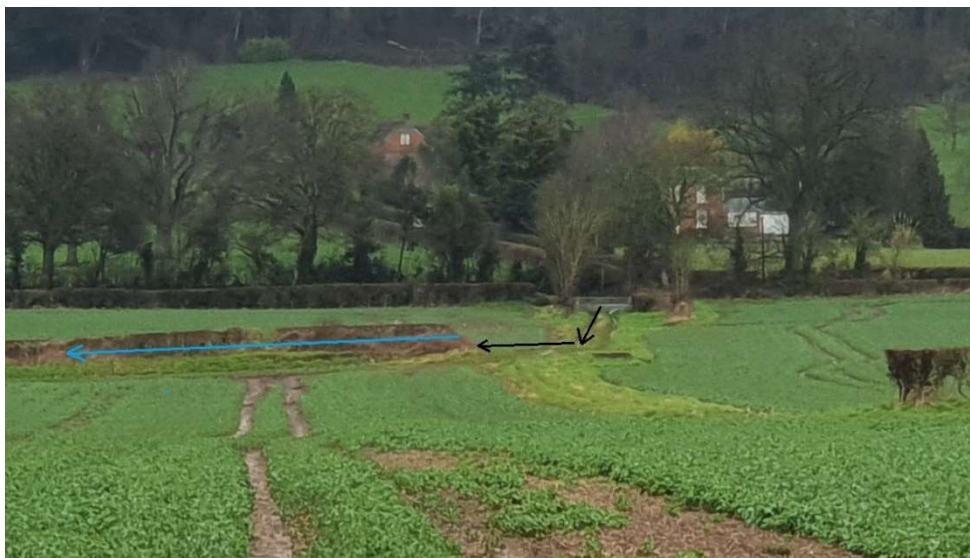
The field to the rear of Glebe Close has a hedgerow and ditch at the foot of the top field. Surface water is not currently managed on the site and the ditch is overgrown. The ditch runs away from the glebe close properties downhill towards the Yazor Brook. If the ditch was cleared and gullies were created to take water from the upper field, then any excess water from the hill and A480 would be directed towards the Yazor Brook and away from the properties in Glebe Close. See below proposed solution

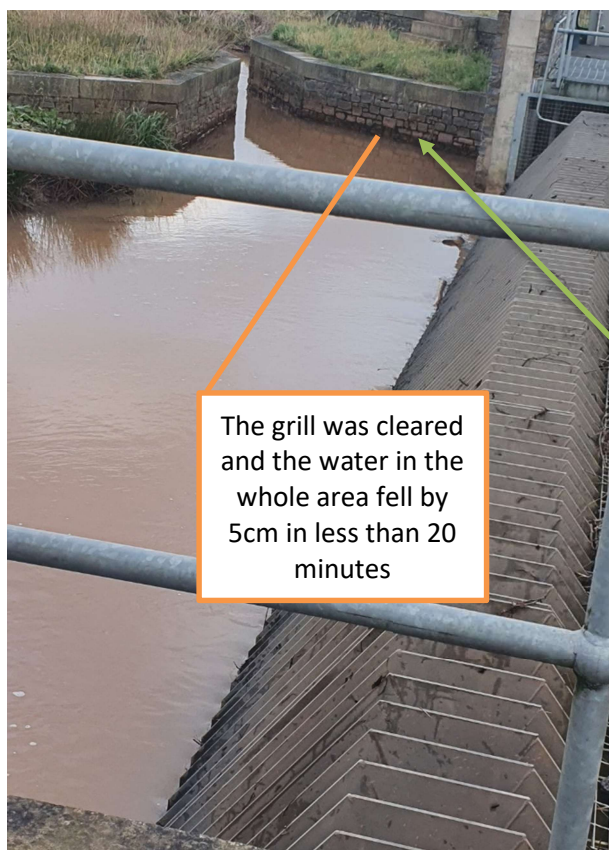
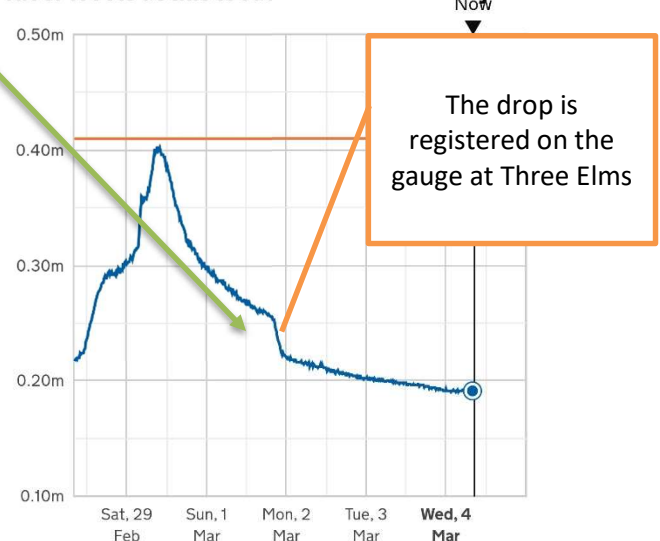
An experiment was conducted on Sunday 1st March 2020 during normal winter level conditions, the grill was cleared, and the level drop was observed as follows:

Whilst not a large drop the experiment does show that debris in front of the grill has a significant effect on the brook level and the scheme has a significantly larger capacity when clear.
