## Credenhill Flood Report – 15<sup>th</sup>/16<sup>th</sup> February 2020

### Background

On the night of 15<sup>th</sup> February, morning of 16<sup>th</sup> February, following several days of unprecedented rainfall onto land already saturated by the wettest winter on record, several properties in Credenhill Parish experienced flooding from surface water. This report aims to highlight the issues to the necessary parties and put forward any steps that can be taken going forward to prevent it from happening again and to reduce flood risk.

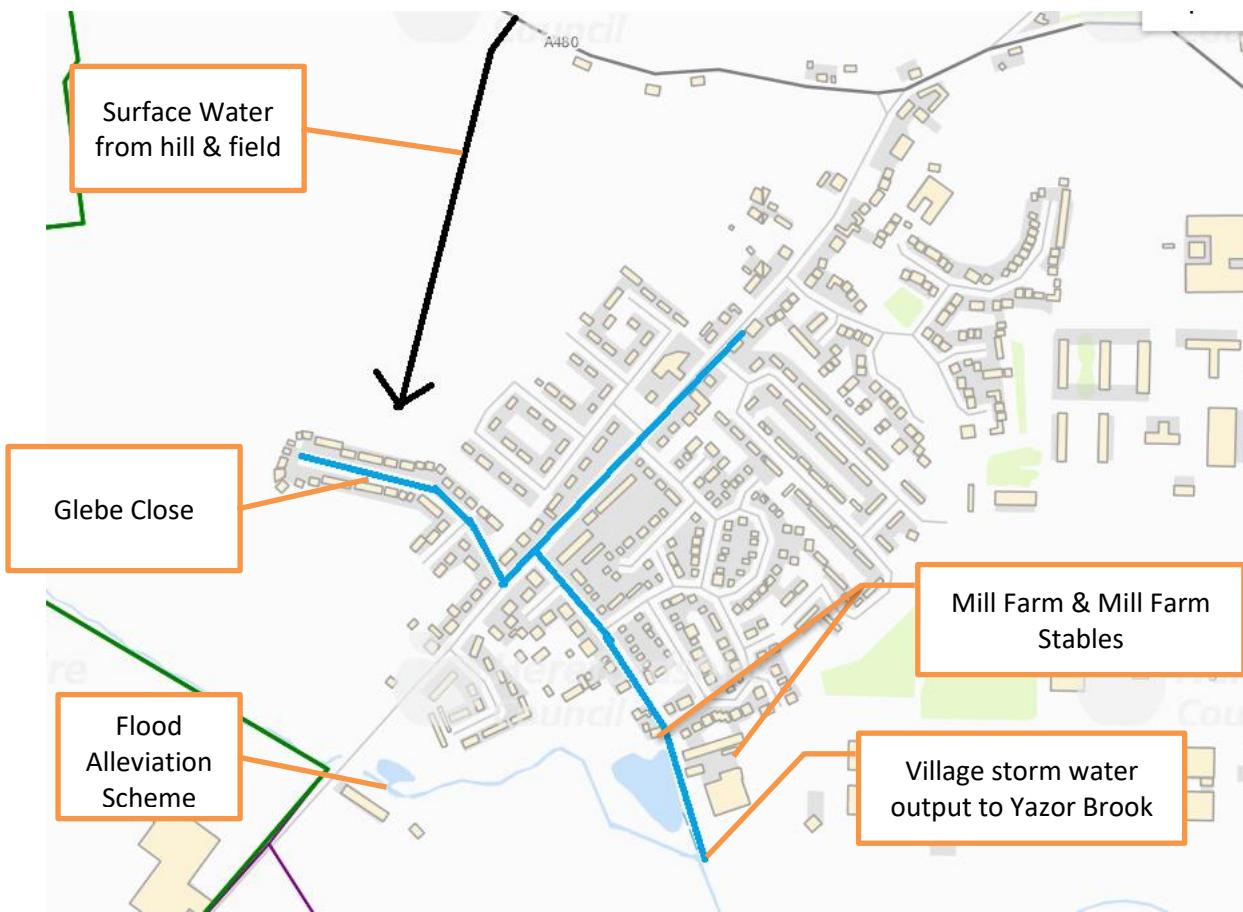
At the same time water from the hill had ran onto the A480 and was entering the farmers gate at the north of the field to the rear of glebe close.

The water followed the lie of the land, helped by several compacted tractor tracks down to the properties directly downhill of the gate. The field was unable to take the additional water due to the unprecedented amount of rain during the winter and therefore congregated at the rear of the properties to the north side of glebe close (numbers 57 – 70). Property owners became aware of the build up at around 3am. Numbers 60 and 61 opened their rear and front garage doors to prevent the water from getting into their homes. This allowed the water to drain from the rear of the properties through onto the road. However, due to the issues with the drains the water was unable to drain effectively from the road. The homes to the south side of Glebe Close, being lower than the road

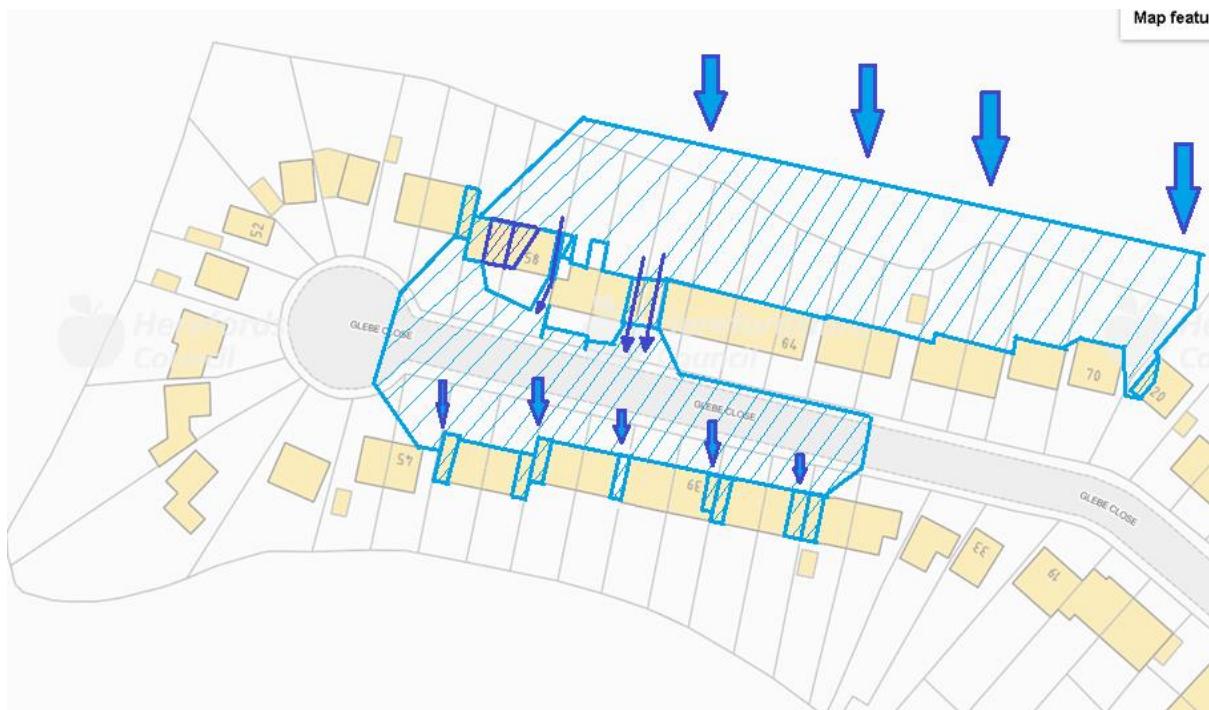
surface, then started to get surface water build up in front of their properties and enter their garages that are at ground level. The fire brigade arrived in time to pump water down the road to prevent any homes on the south side of glebe close from flooding. 2 properties at the north side (no57 & 58) were flooded by 1cm in their living areas. The surface water drained gradually over the next 24 hours.

The below diagram shows the homes affected; this was created by speaking to homeowners in Glebe Close (See appendix 1):

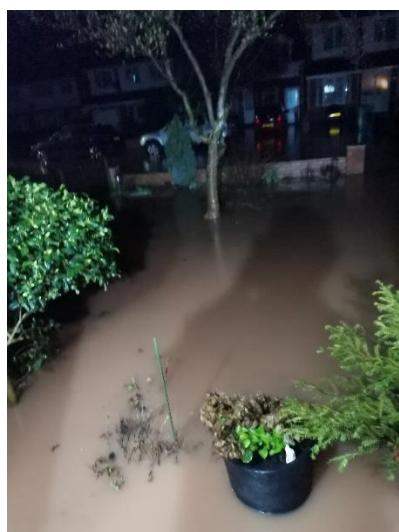
No.43 looking towards 58

The following images show the extent of the flooding during the incident:

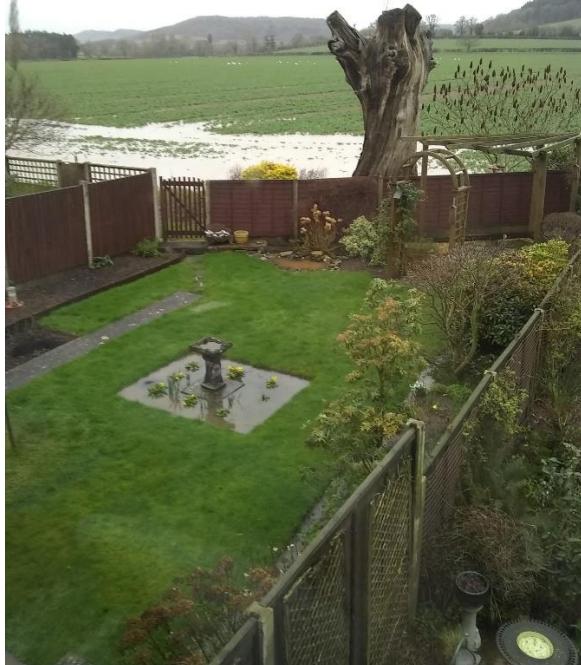
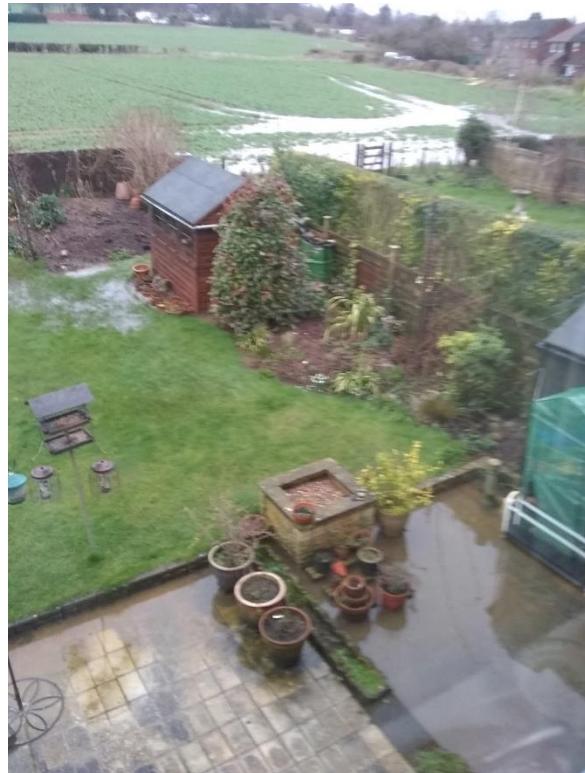
The below images show the field the next morning after the incident:

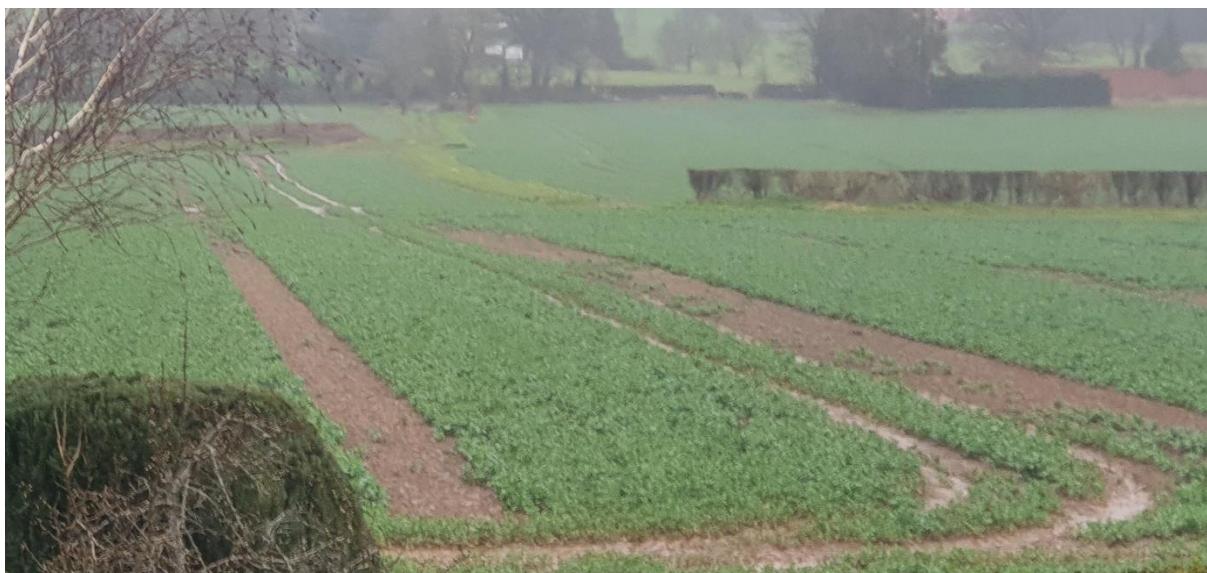
The below image shows the compacted tracks in the field (image taken after the water had drained):

Another solution would be to create a ditch and ridge to the rear of the Glebe Close properties. The farmer could also farm the land in a direction leading away from the properties so that the tram lines follow the slope towards the Yazor Brook instead of the slope towards the homes.

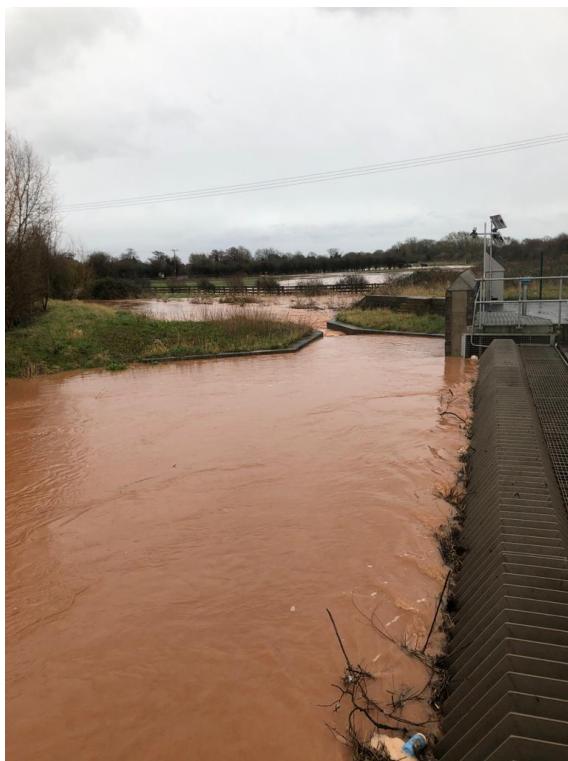
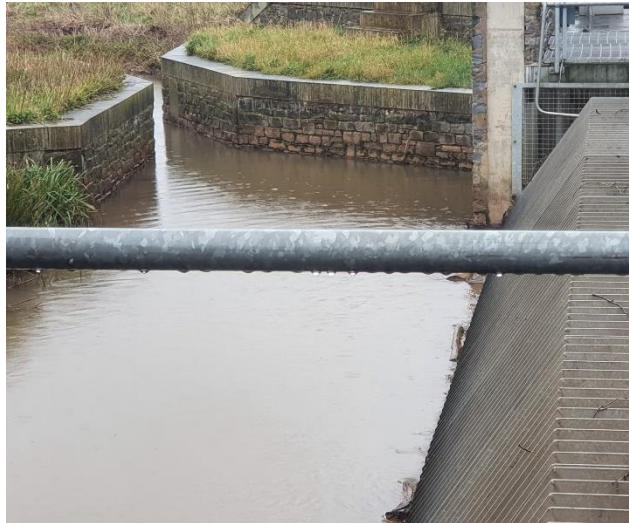
Flood Alleviation Scheme at 11am on 16<sup>th</sup> February compared to normal winter level

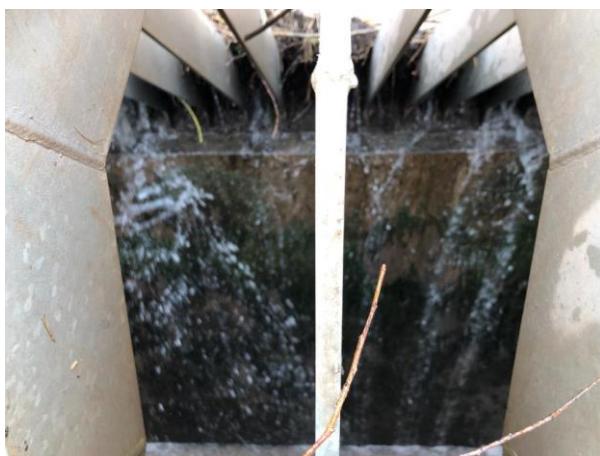
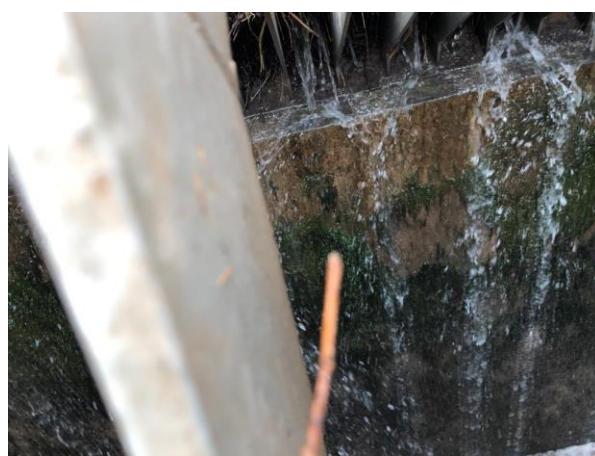
Blocked Grill:

While compiling this report it was established that a resident had cleared the grill on the flood alleviation scheme at 11.15am on 16<sup>th</sup> February 2020, the below images show the effect of clearing the grill.

Images show the difference in flow between a cleared grill and a blocked grill

It is clear from the images of the scheme being cleared that keeping the grill clear is an essential part of running an efficient scheme. If the grill had been kept clear then arguably the brook would never have reached the levels that caused flooding at the levels that were seen throughout the city (Roman Road, Three Elms, Ledbury Road - Texaco Garage). The backing up of the drainage pipe on Mill Lane, caused by the abnormally high level of Yazor Brook, which in turn caused Mill Farm & Mill Farm Stables to flood; would this of happened if the grill had been kept clear?

The culverts contain remote level sensors and the scheme has cameras to monitor the grill, could these be used to trigger an emergency response to ensure that Balfour Beatty are called out to clear the grill regardless of time/day? A 2-person team clearing the grill to ensure that the water is shepherded down the pipe would be better than having to deal with problems reactively after the event.

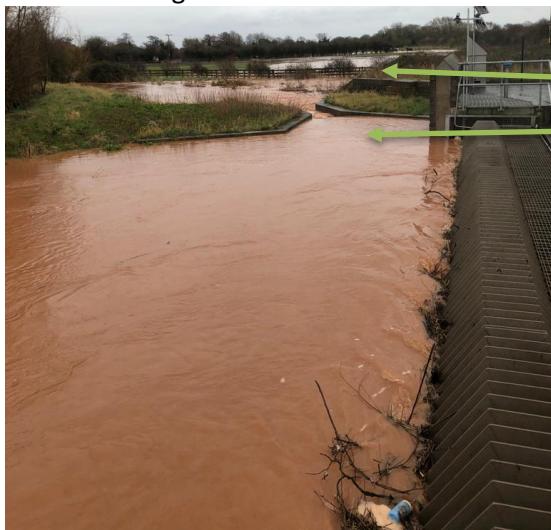
Before clearing

Flood Alleviation Scheme on 16<sup>th</sup> February 2020 at 12:00pm (after a resident had cleared the grill) compared to before.

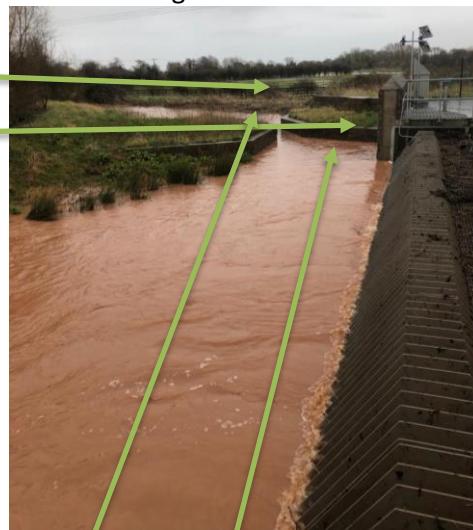
After clearing

Clearing of the grill reduced the level significantly in less than an hour; it also allowed the field to drain and prevented the brook from flowing into the field.

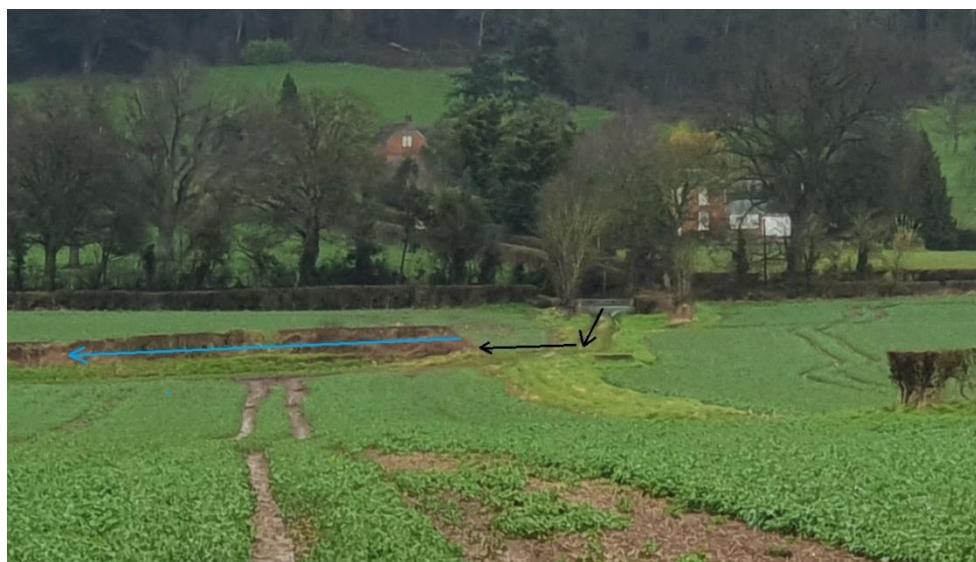
The field to the rear of Glebe Close has a hedgerow and ditch at the foot of the top field. Surface water is not currently managed on the site and the ditch is overgrown. The ditch runs away from the glebe close properties downhill towards the Yazor Brook. If the ditch was cleared and gullies were created to take water from the upper field, then any excess water from the hill and A480 would be directed towards the Yazor Brook and away from the properties in Glebe Close. See below proposed solution

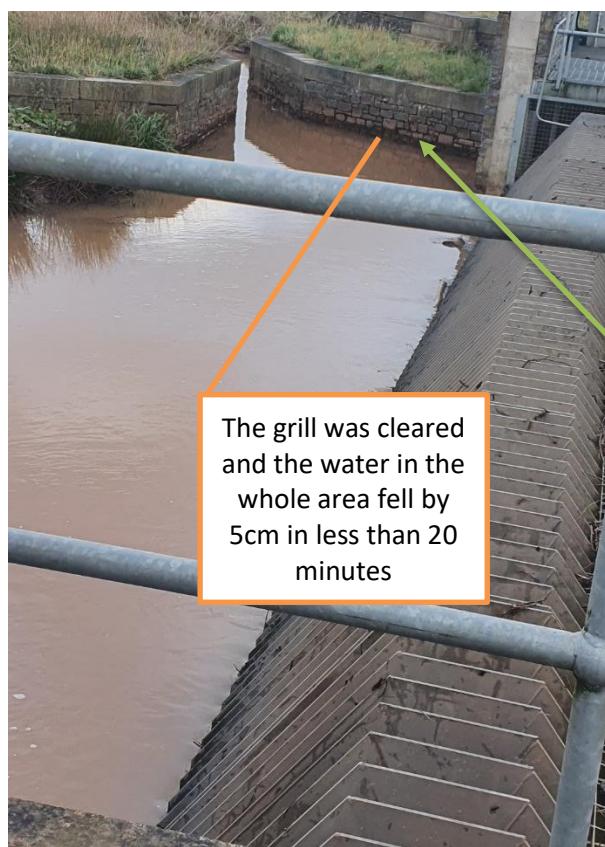
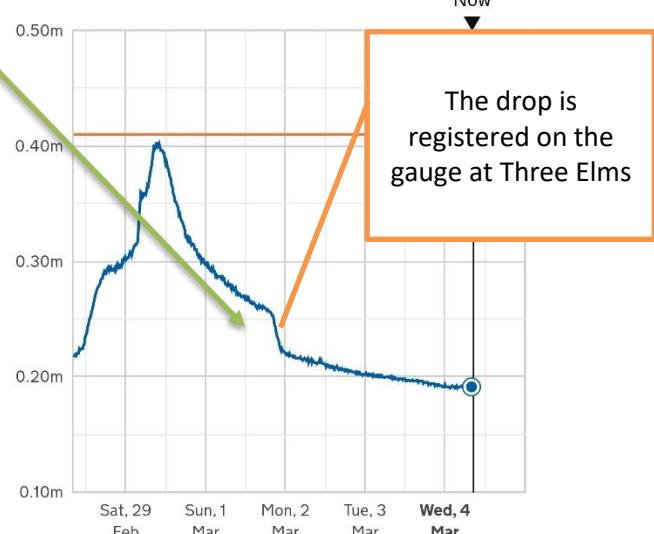
An experiment was conducted on Sunday 1<sup>st</sup> March 2020 during normal winter level conditions, the grill was cleared, and the level drop was observed as follows:

Whilst not a large drop the experiment does show that debris in front of the grill has a significant effect on the brook level and the scheme has a significantly larger capacity when clear.
